Bolton Low Houses Infiltration Reduction Plan

Executive summary

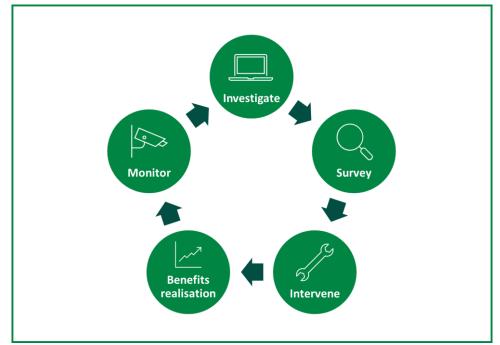
Figure 1: Iterative process to investigate, identify and address groundwater infiltration

Bolton Low Houses in Cumbria is currently in the monitoring stage (see Figure 1) to address infiltration and reduce spills at the Bolton Low Houses Wastewater Treatment Works Storm Tank Overflow (017570012ST). A desktop assessment concluded that there is the possibility of groundwater infiltration but not likely a significant amount that would reduce spill count if addressed. Surveys confirmed the presence of infiltration and remedial works were completed in Spring 2025.

Bolton Low Houses is currently in the monitoring stage of identifying and addressing infiltration (see Figure 1). The site will follow the iterative process displayed in Figure 1 to monitor the efficacy of the remedial works and identify new points of infiltration, should they arise.
