**Caldbeck**

# **Infiltration Reduction Plan**

**Last Updated: March 2025**

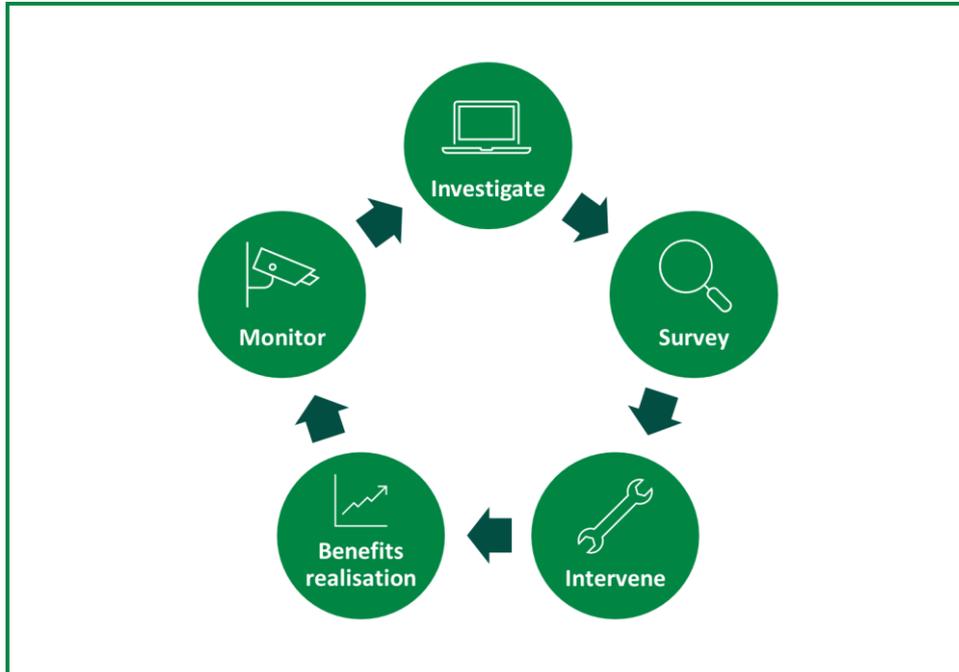
Figure 1: Iterative process to investigate, identify and address groundwater infiltration

Caldbeck in Cumbria is in the monitor stage (see Figure 1) to address infiltration and reduce spills at the Caldbeck Wastewater Treatment Works Storm Tank Overflow (017670113ST). A desktop assessment concluded that there is a low likelihood of groundwater infiltration contributing to spills and CCTV surveys also did not reveal infiltration.

Caldbeck is in the monitoring stage of identifying and addressing infiltration (see Figure 1) to identify emerging points of infiltration, should they arise.

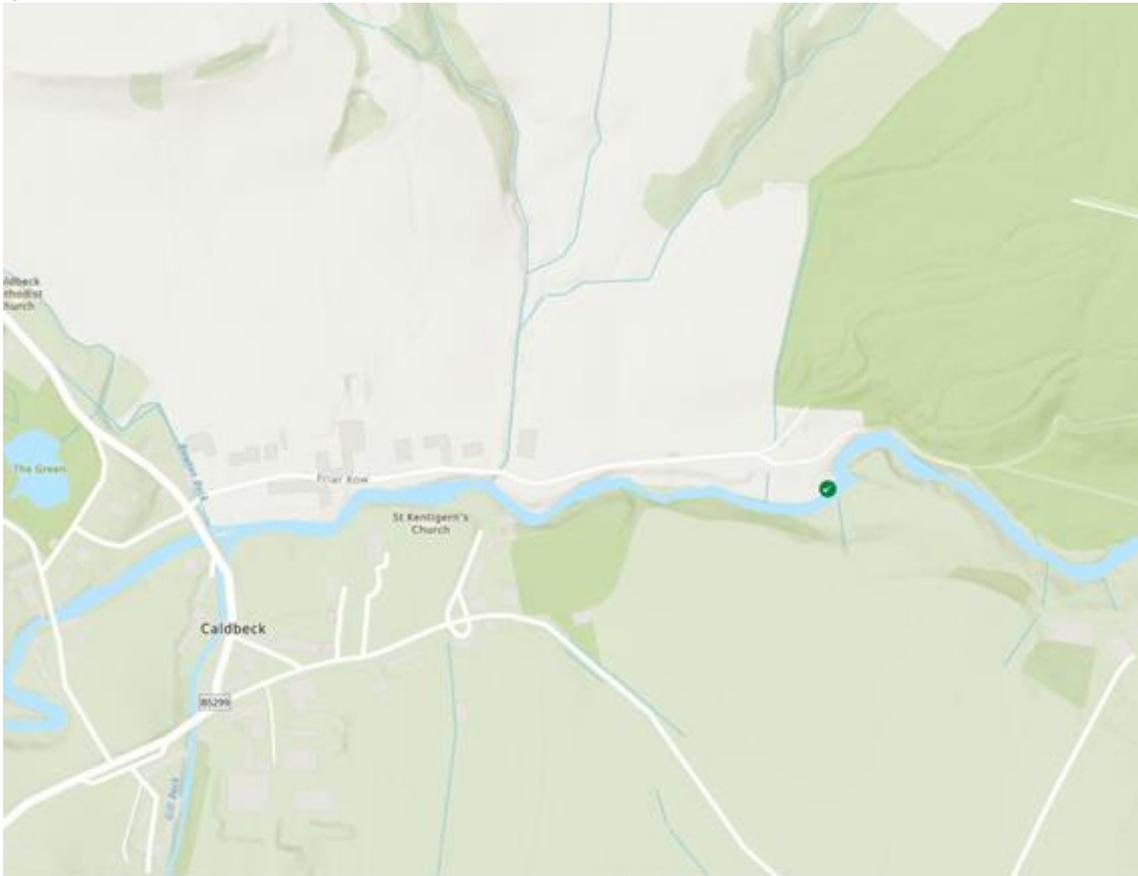
**Figure 2:** United Utilities – Better Rivers – Storm Overflow Map (October 2024). The green dot marks the Caldbeck Wastewater Treatment Works Storm Tank Overflow.
