Gleaston

Infiltration Reduction Plan

Last Updated: March 2025

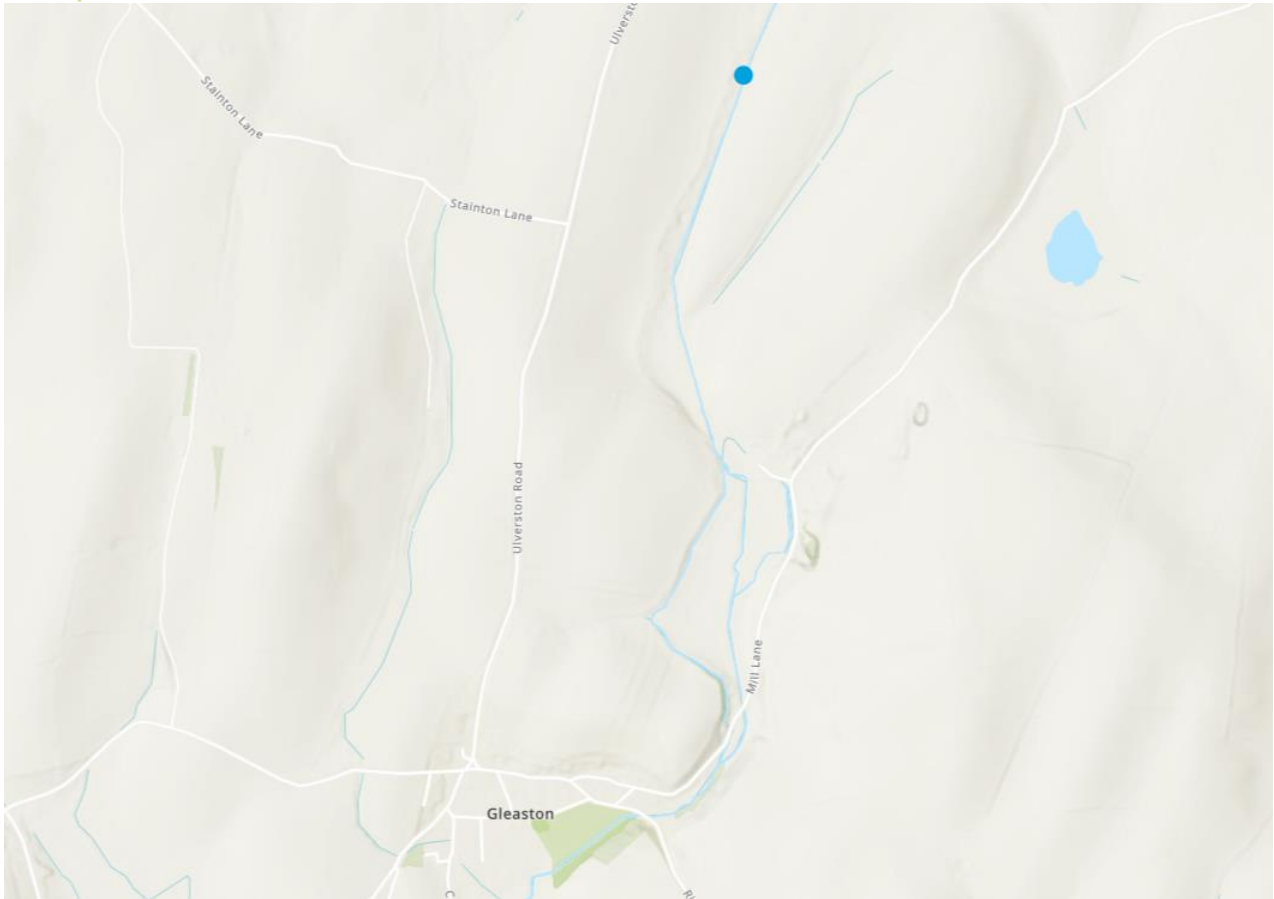
Figure 2: United Utilities – Better Rivers – Storm Overflow Map (December 2024). The blue dot marks the Gleaston Castle CSO Storm Overflow.
