**Crosby Garrett**

# **Infiltration Reduction Plan**

**Last Updated: September 2026**

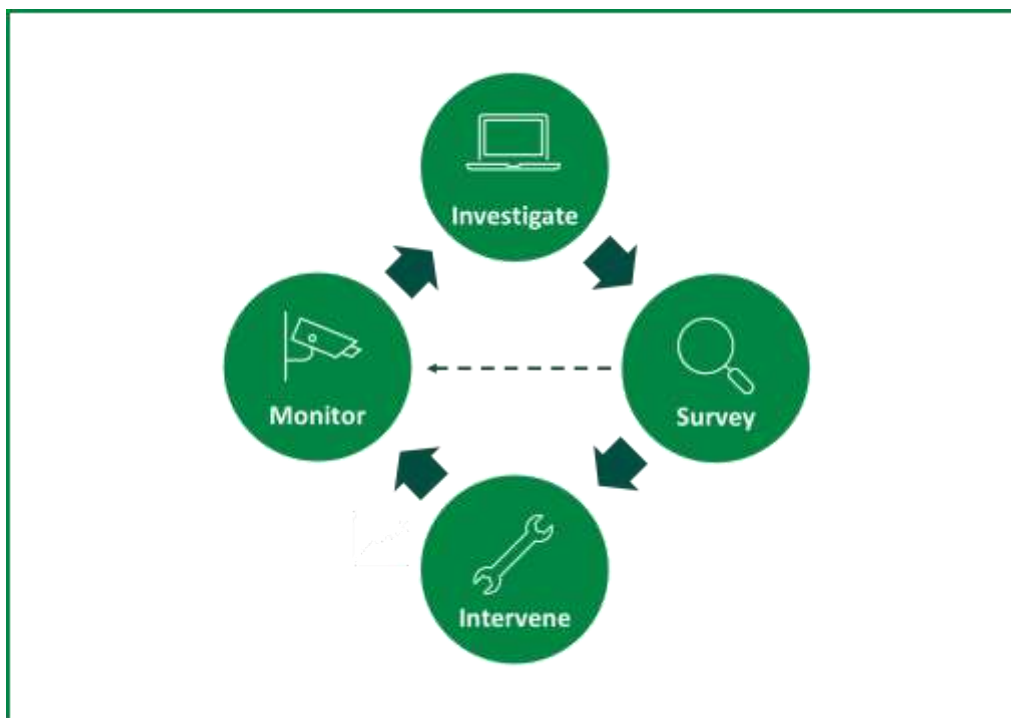
**Figure 1:** Iterative process to investigate, identify and address groundwater infiltration

Crosby Garrett in Cumbria is currently in the survey stage (see Figure 1) to address infiltration and reduce spills at the Crosby Garrett Wastewater Treatment Works Storm Overflow. An initial desktop assessment concluded that there was a low likelihood of groundwater infiltration. However, CCTV surveys confirmed the presence of infiltration, and interventions to address this were completed in Summer 2025. An additional survey was completed in Summer 2026 and is currently being reviewed.

Crosby Garrett is currently in the survey stage of identifying and addressing infiltration. The site will follow the iterative process displayed in Figure 1 to monitor the efficacy of the remedial works and identify new points of infiltration, should they arise.
