Gilsland

Infiltration Reduction Plan

Last Updated: November 2024

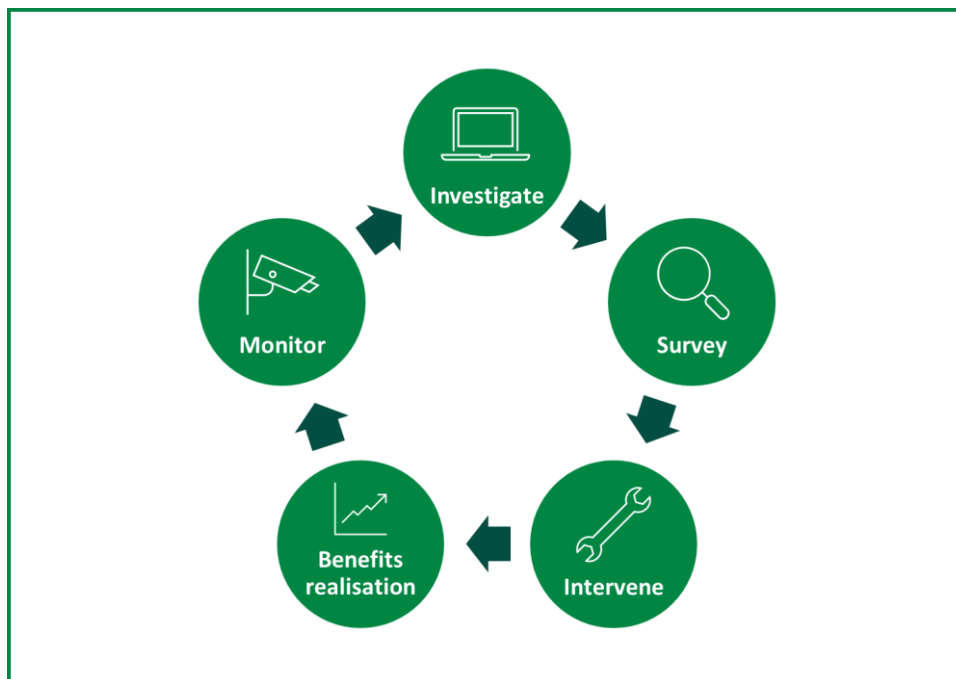
Figure 1: Iterative process to investigate, identify and address groundwater infiltration

Gilsland is currently in the survey stage (see Figure 1) to address infiltration and reduce spills at the Gilsland Wastewater Treatment Works Storm Overflow (017670091SO). A desktop assessment concluded that there is the possibility of groundwater infiltration. Surveys are underway to clarify this as well as the exploration of Natural Flood Management to manage rural run off if this is found to be a significant contributing factor in spill numbers.

Gilsland is currently in the surveying stage of identifying and addressing infiltration (see Figure 1). If the CCTV survey reveals groundwater infiltration, interventions will be considered, and the site will follow an iterative intervention regime to monitor the efficacy of the solution. Remedial works at Gilsland could include, but not be limited to, relaying sewers, lining sewer or sealing manholes. This would be expected to be completed in 2025.

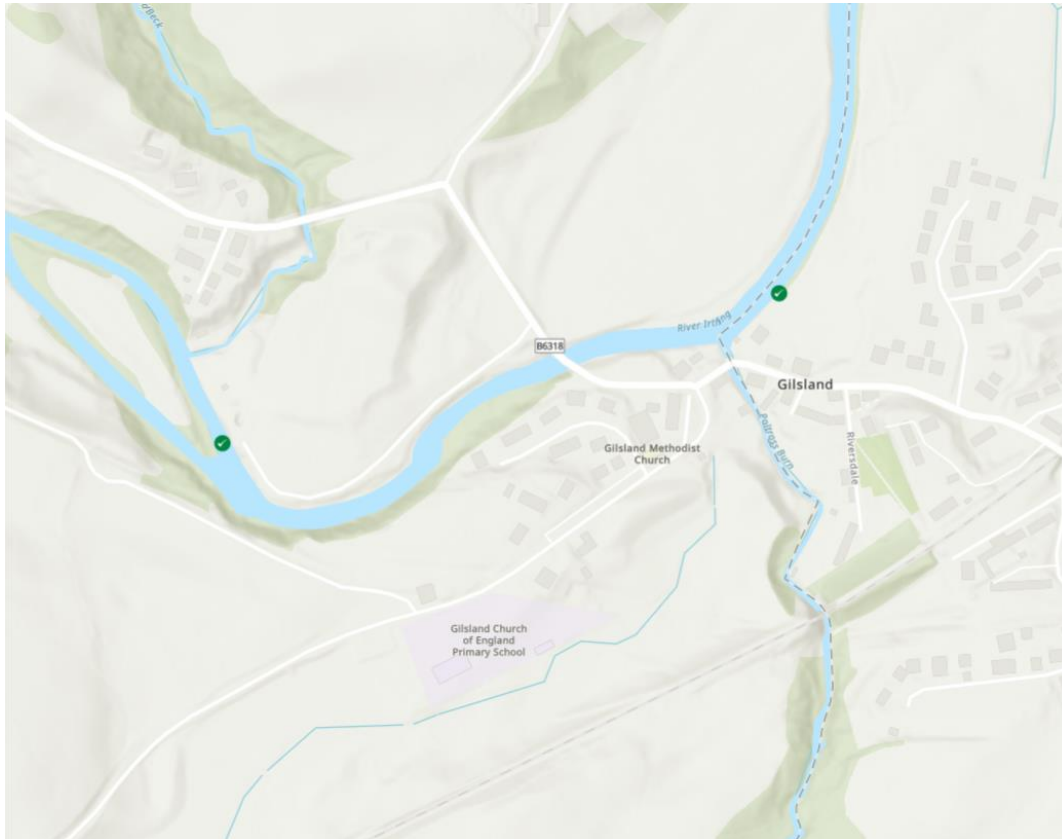
Figure 2: United Utilities – Better Rivers – Storm Overflow Map (November 2024). The green dot on the left of the image marks the Gilsland Wastewater Treatment Works Storm Overflow.
